Water Quality Monitoring Report: Columbia County Soil and Water Conservation District Water Quality Trend Monitoring Program 2017

Lower Columbia Estuary Partnership

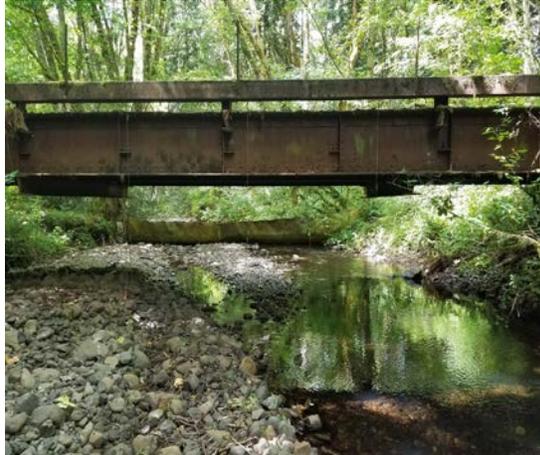
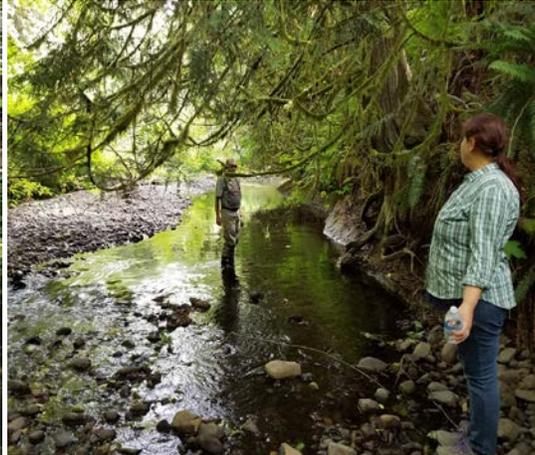
Location: Looking up stream at bridge, looking down stream towards data logger placement

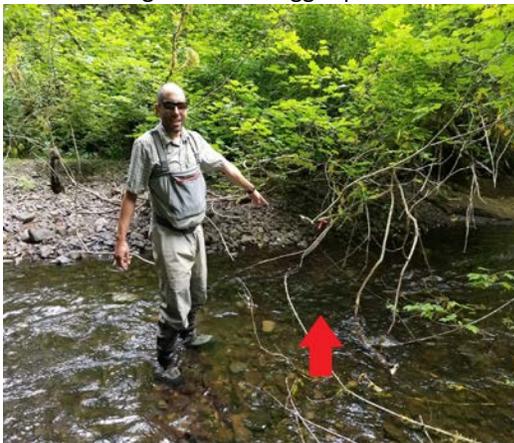
Matt standing near data logger placement location, under vine maple (flagged with pink tape)

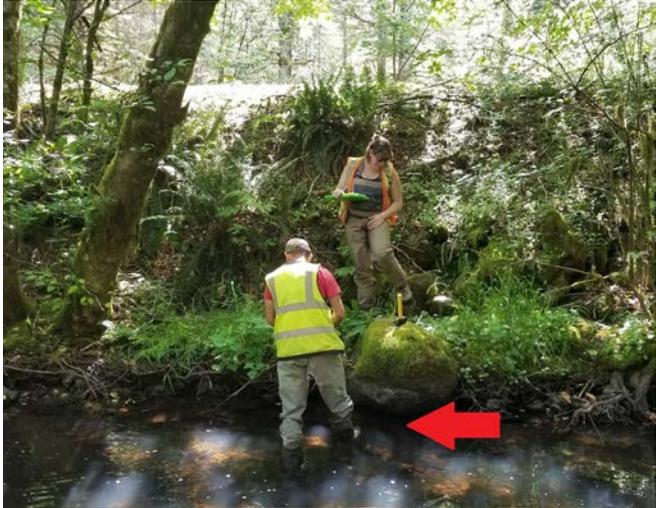
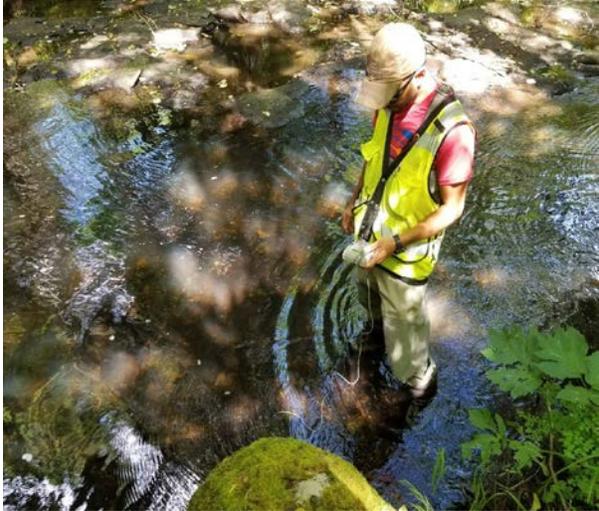
Location images: Data logger located near large rock along the river bank

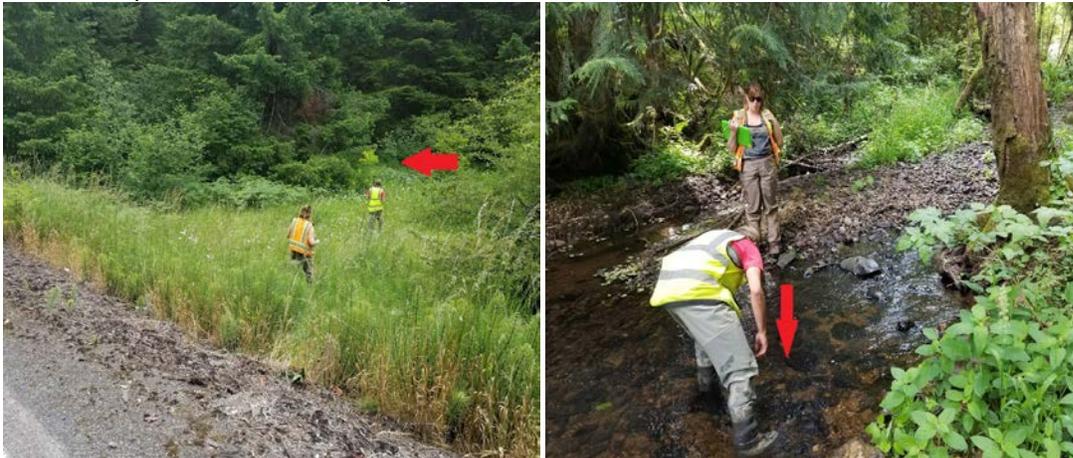
Grassy opening along right side of road side north of car pull out, data logger is located near flagging next to salmon berry shrub and cedar stump

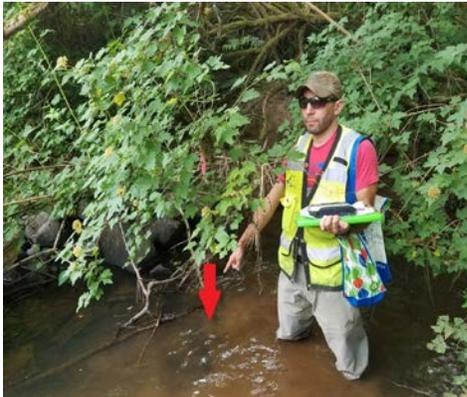
Data logger located under Currant shrub on far side of stream.

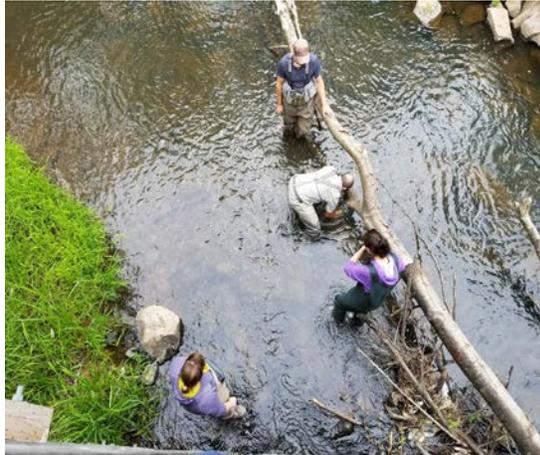
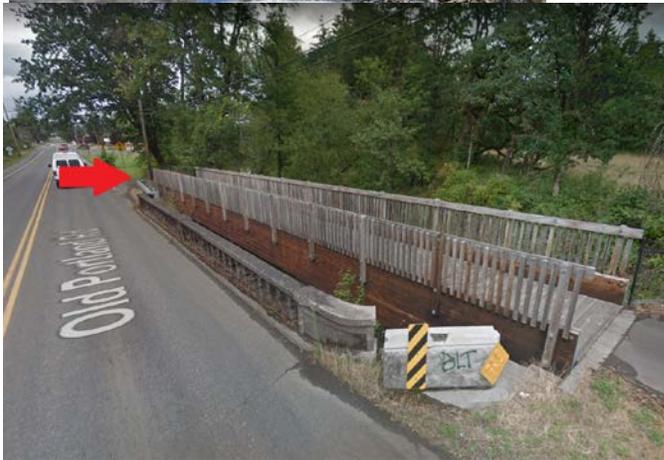
Location Image (looking down from the bridge, Matt is bending over data logger placement):

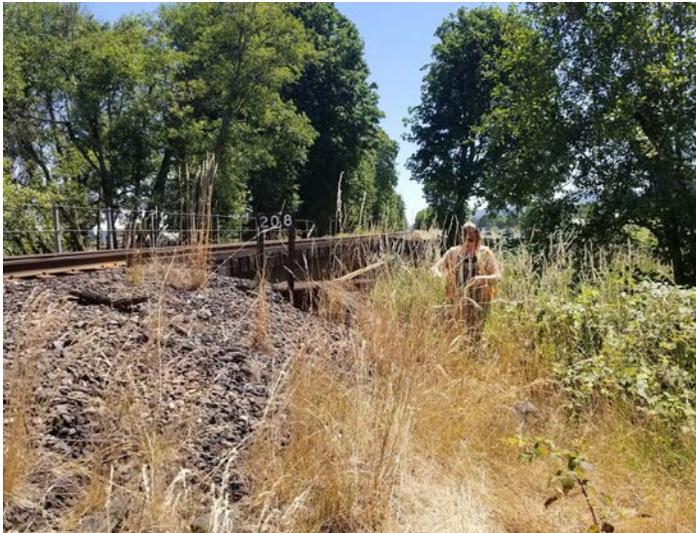
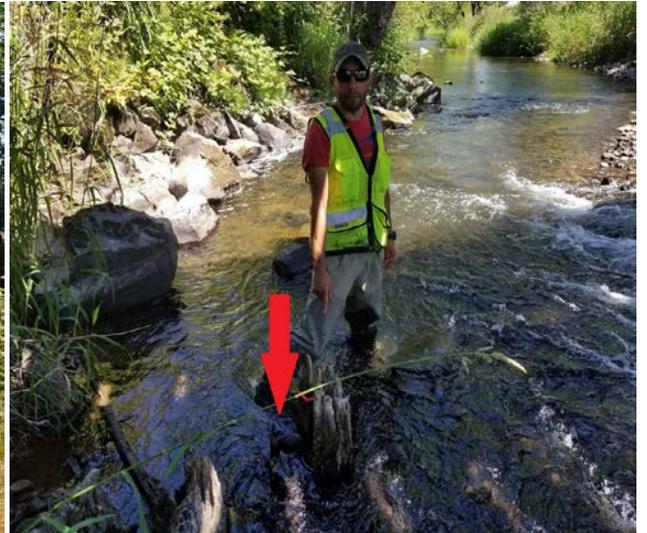
Enter stream on the north bank at the railroad bridge (large patch of reed canarygrass) crossing. Data logger tied to old piling on north bank of stream under railroad bridge.

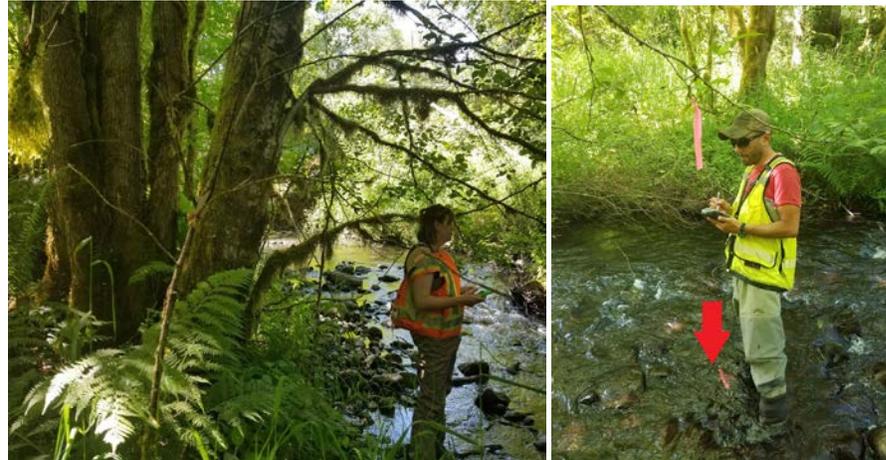
Data logger located downstream of bridge under an alder tree (flagged)
